Chemical Process Safety

Learning from
Case Histories

Third Edition

ROY E. SANDERS

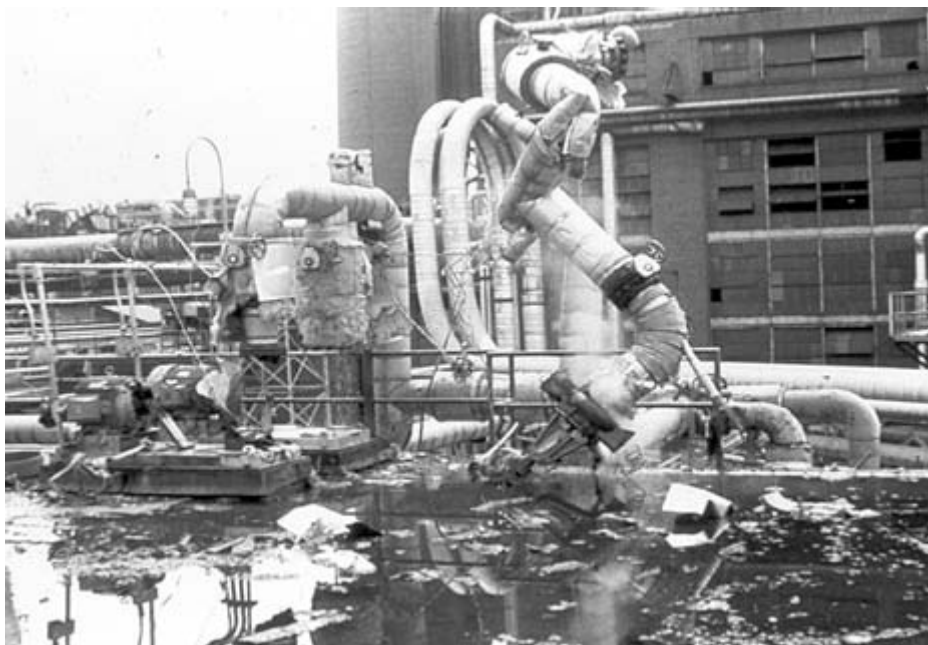
FIGURE 7-15 Heavily damaged condensate pump installation. Courtesy of Eastman Chemical Company.

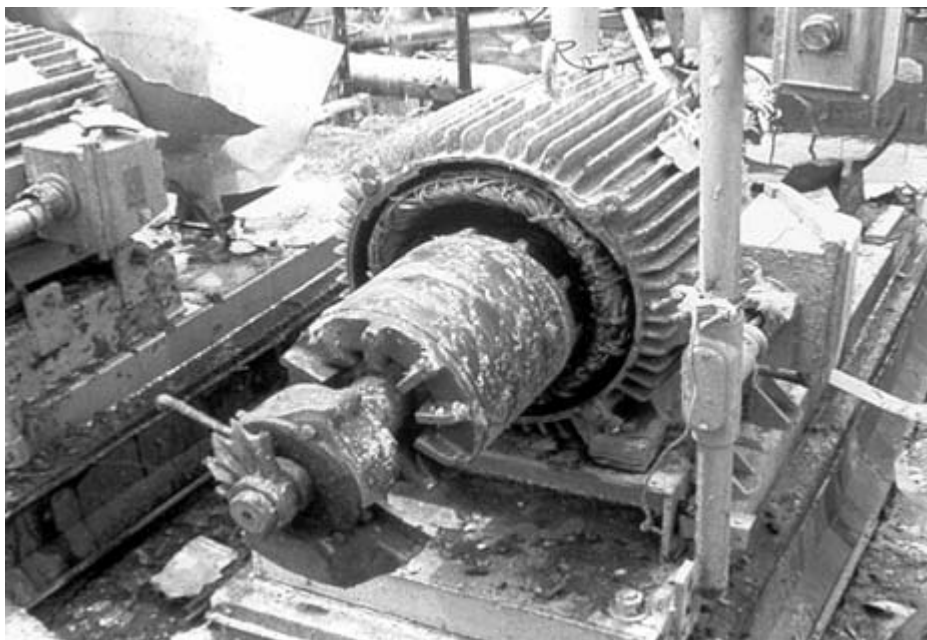
FIGURE 7-16 Explosion forces rotor out of condensate pump motor. Courtesy of Eastman Chemical Company.

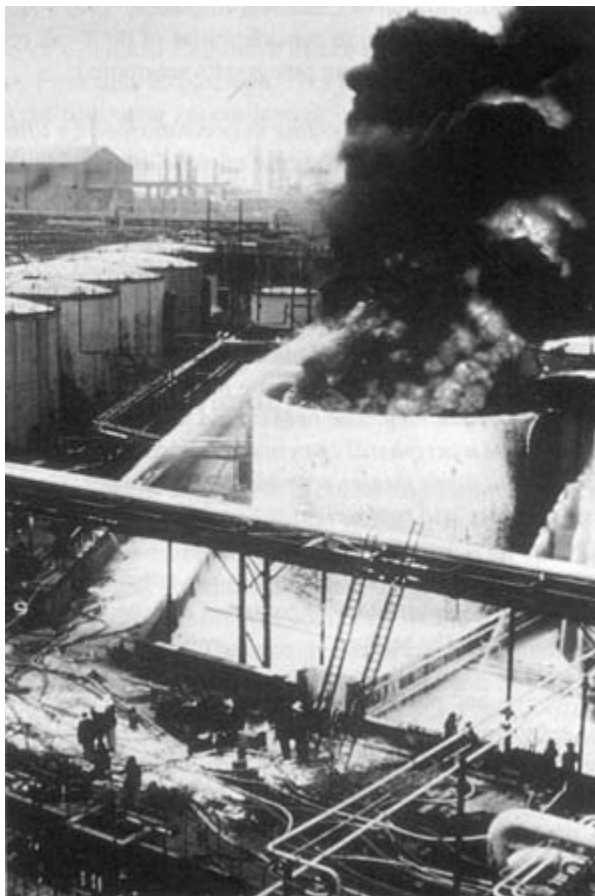
FIGURE 8-3 A fire in a giant floating roof crude oil tank. Courtesy of the Institution of Chemical Engineers. This photo can be found in Hazard Workshop Module No. 6, "Preventing Emergencies in the Process Industries, Volume 1."

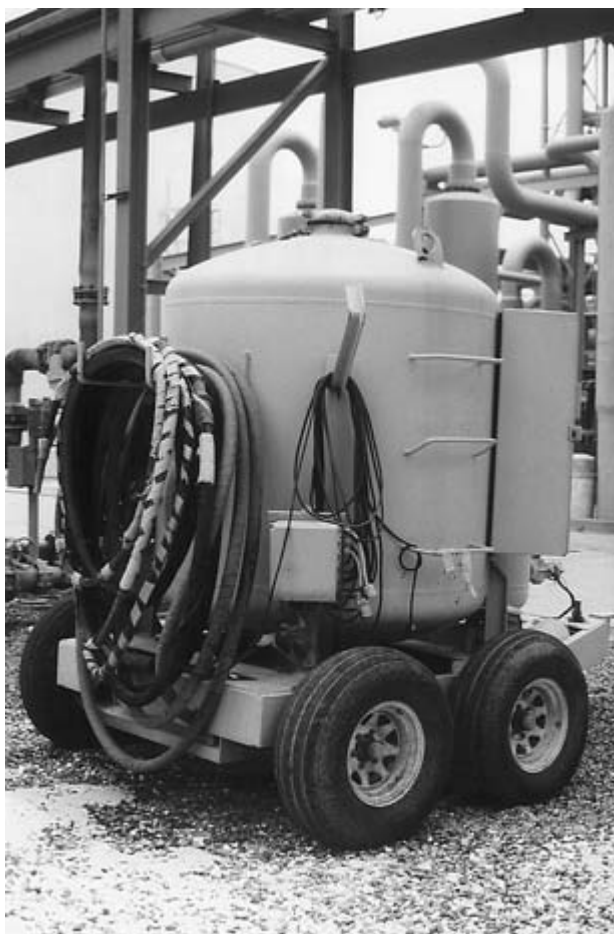
FIGURE 8–4 Repairs to a portable sandblast pot do not meet specifications and the lid flies off.

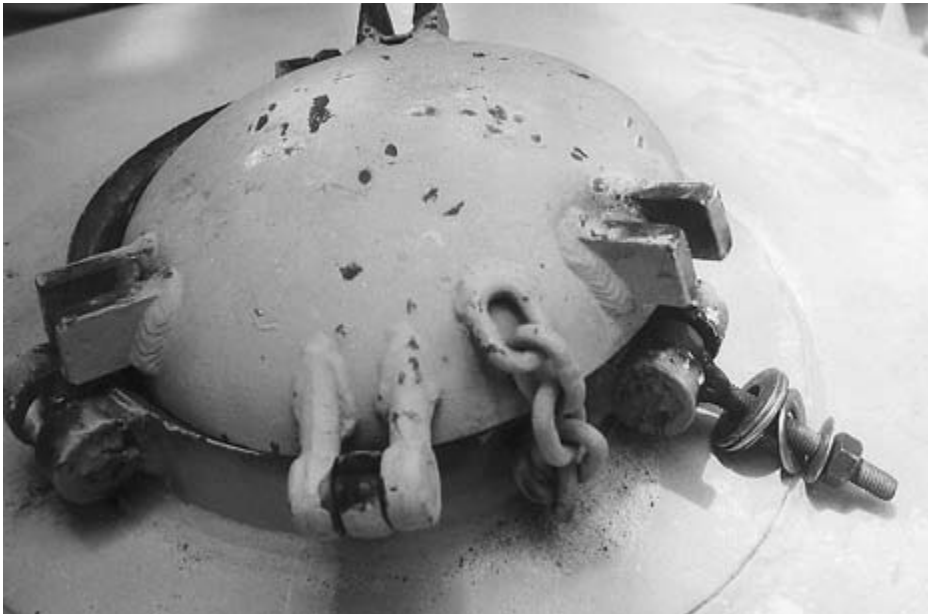
FIGURE 8–5 A close-up look at the quick closure bolts that failed on the sand pot.

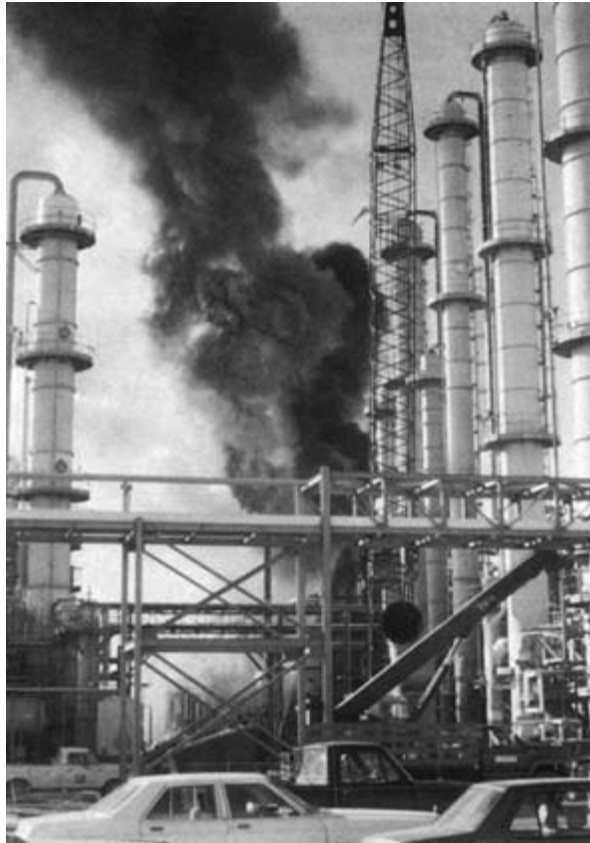
FIGURE 8-6 Fire in solvents plant as seen from the road. Courtesy of G. O. Heintzen.

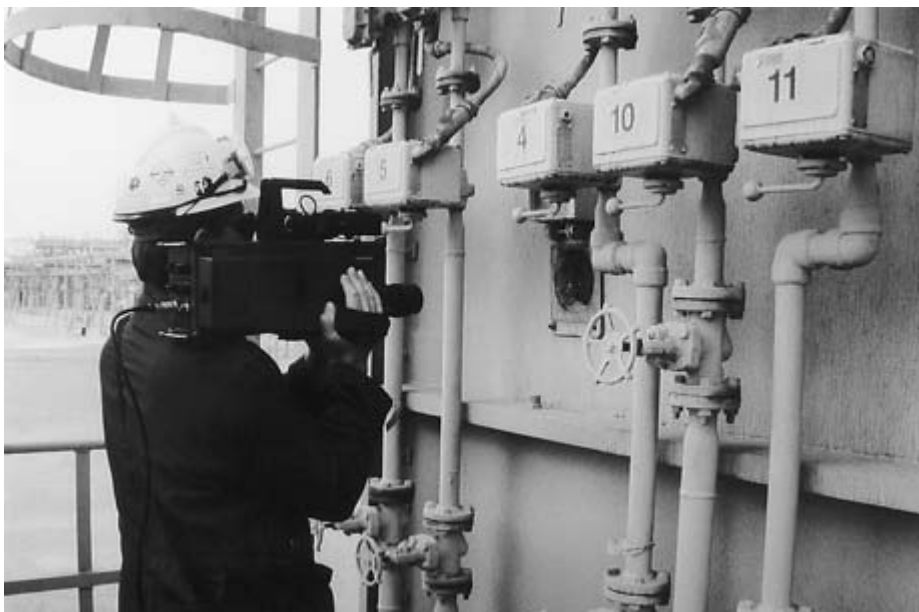
FIGURE 10-5 An inspector using an infrared camera periodically monitors furnace tube temperatures through the inspection port holes.

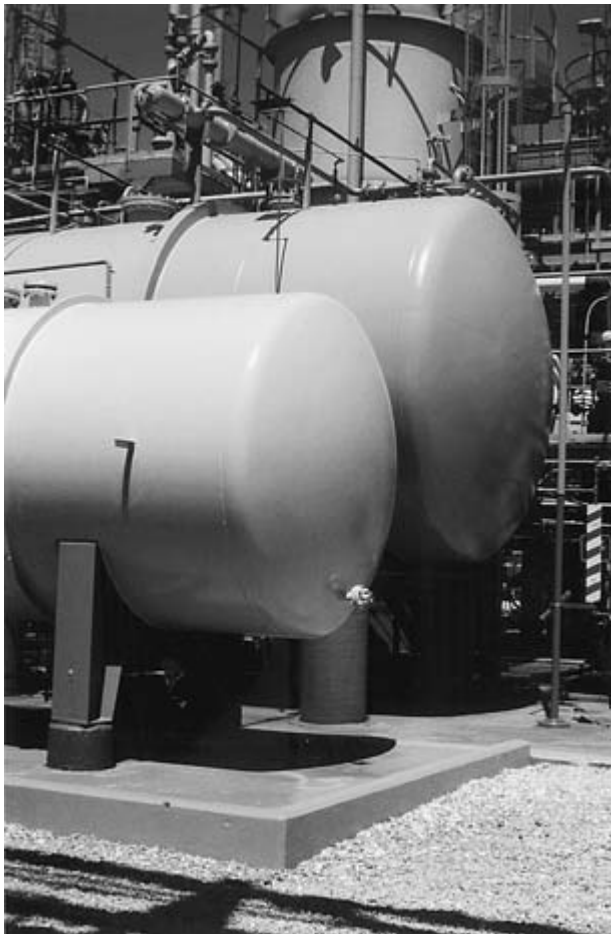
FIGURE 10–7 Well-maintained pressure vessels (over 30 years old) still safely handling hazardous materials.

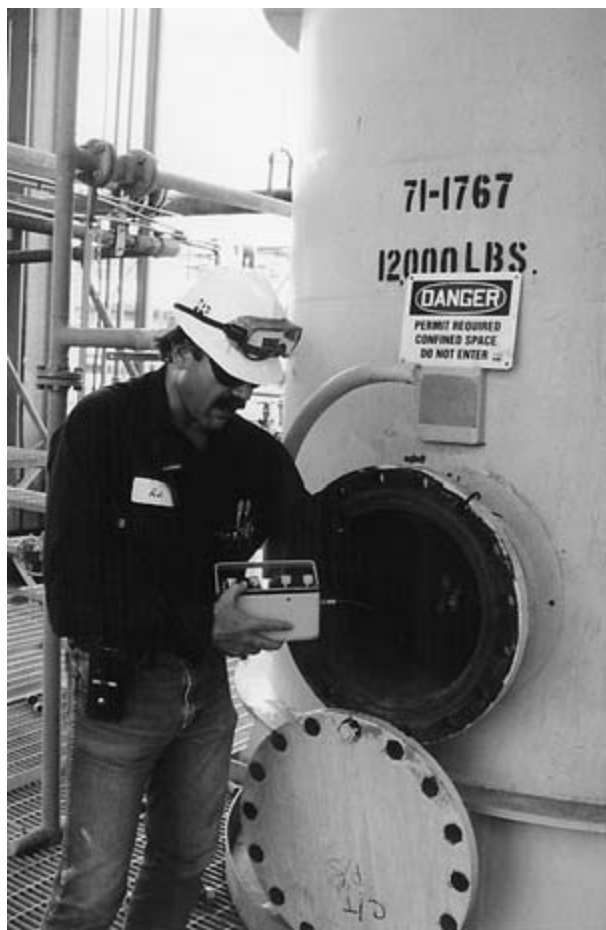
FIGURE 10–8 An operations foreman checks for blinding and samples the vessel's atmosphere before tank entry.

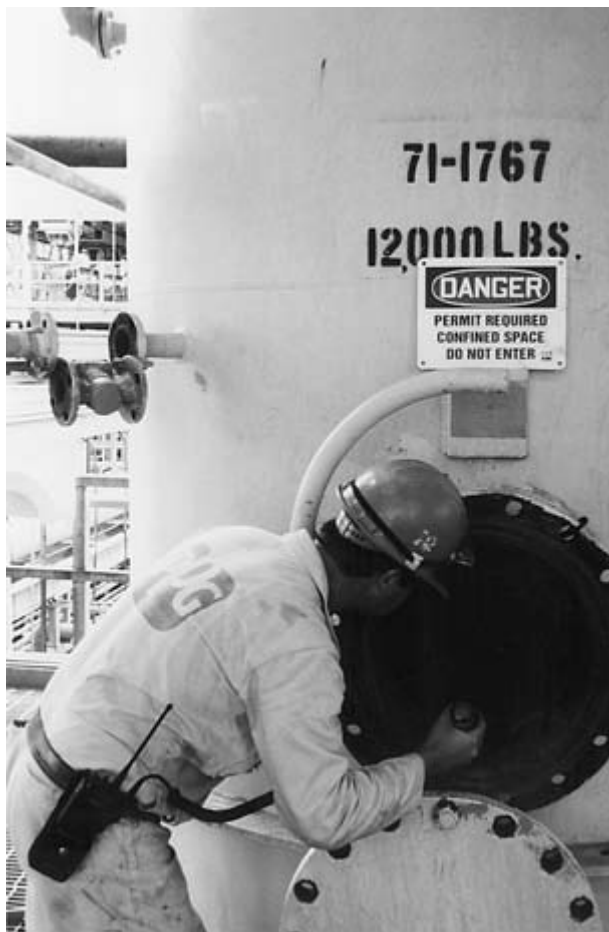
FIGURE 10-9 A pressure vessel inspector making an initial assessment of the vessel and determines any special inspection needs, such as ladders, scaffolding, or extra lighting.

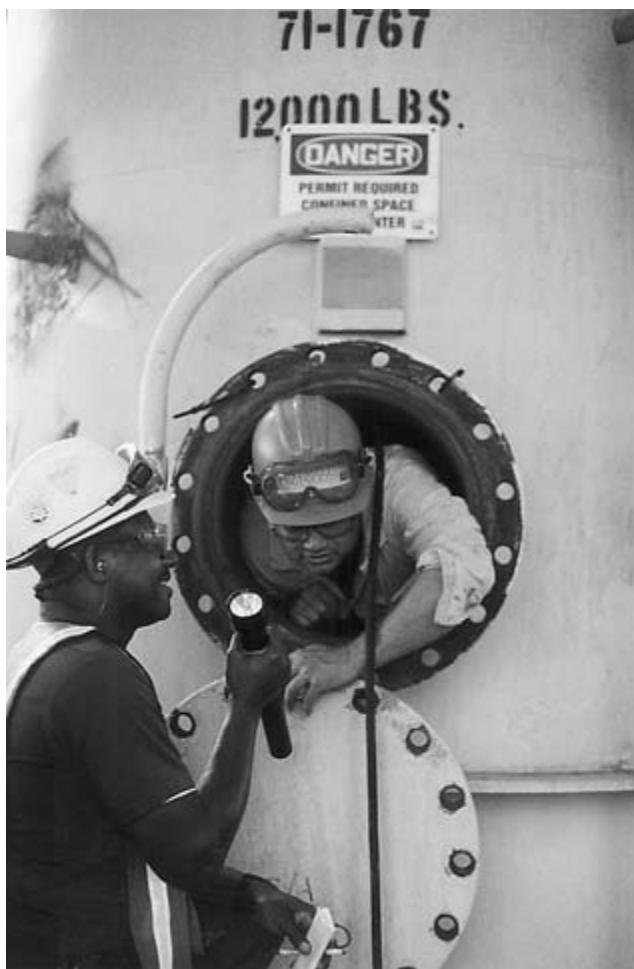
FIGURE 10–10 A pressure vessel inspector enters the confined space after the vessel is blinded, tested, and cleared, but still relies on a manway watch.

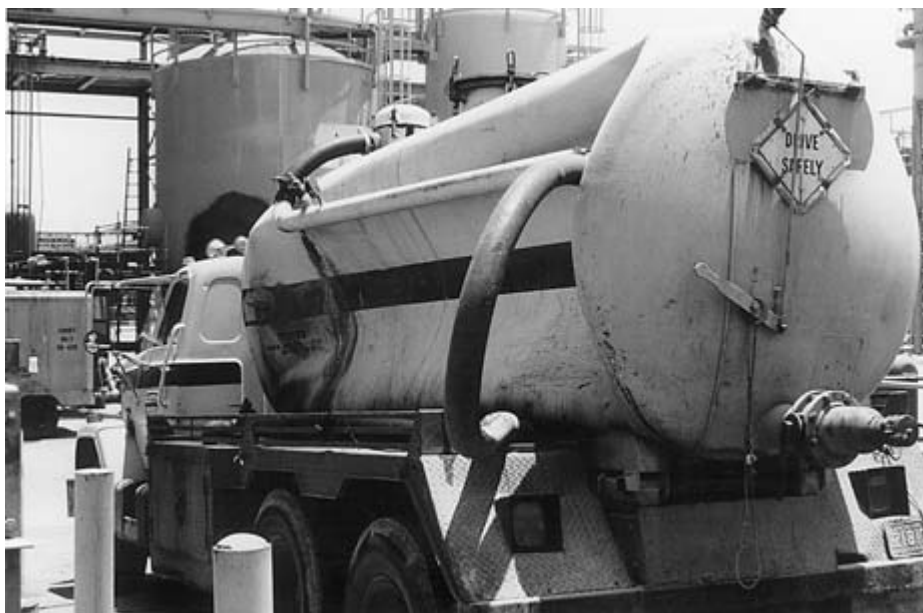
FIGURE 10-12 A collapsed service company vacuum truck signals an inadequate mechanical integrity program.

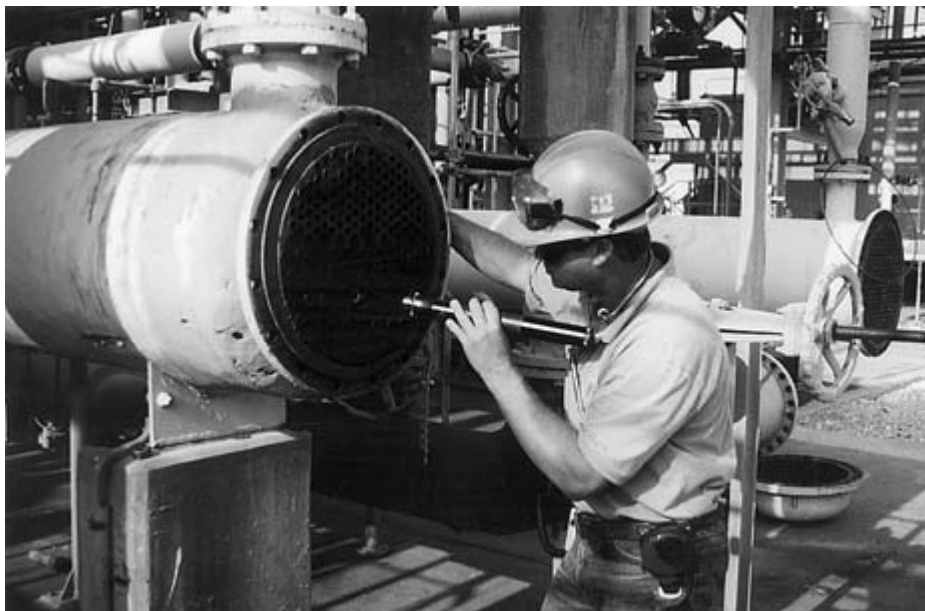
FIGURE 10-14 An inspector examines the condition of the tubes on a condenser. Water-side corrosion can occur if water treatment is insufficient.

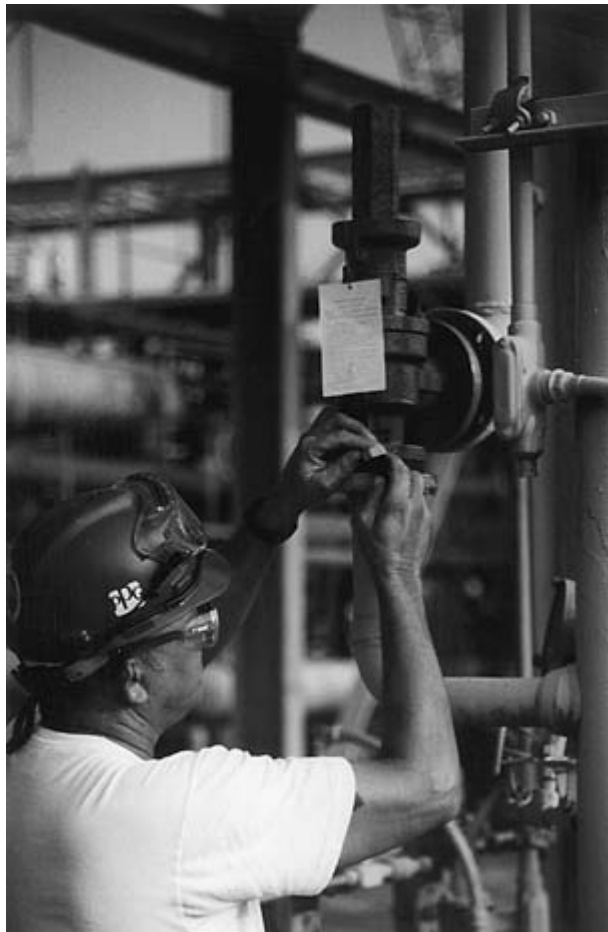
FIGURE 10–17 A mechanic is removing an SRV from a unit. The mechanic records the condition of the inlet and outlet piping components on the tag before the valve is sent for testing.

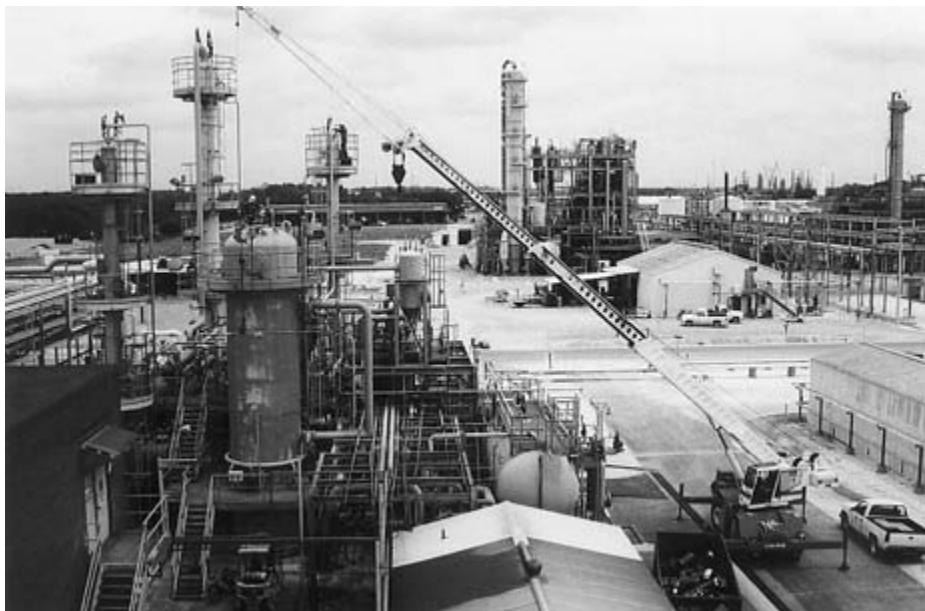
FIGURE 10–19 A crane is lifting a recently tested and reconditioned safety relief valve to reinstall on a reactor.

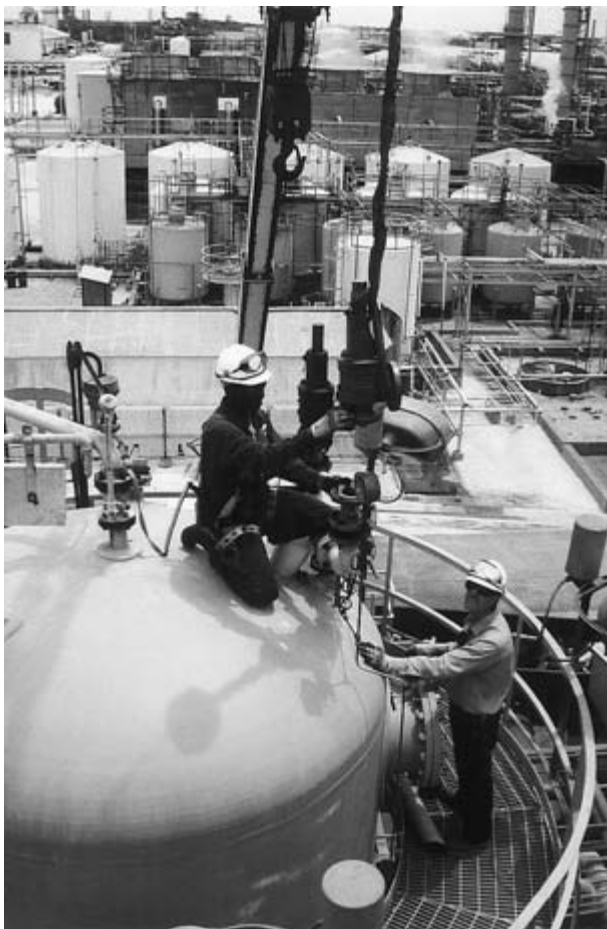
FIGURE 10–20 A mechanic is reinstalling an SRV after it was tested in the shop and raised into position by a crane.

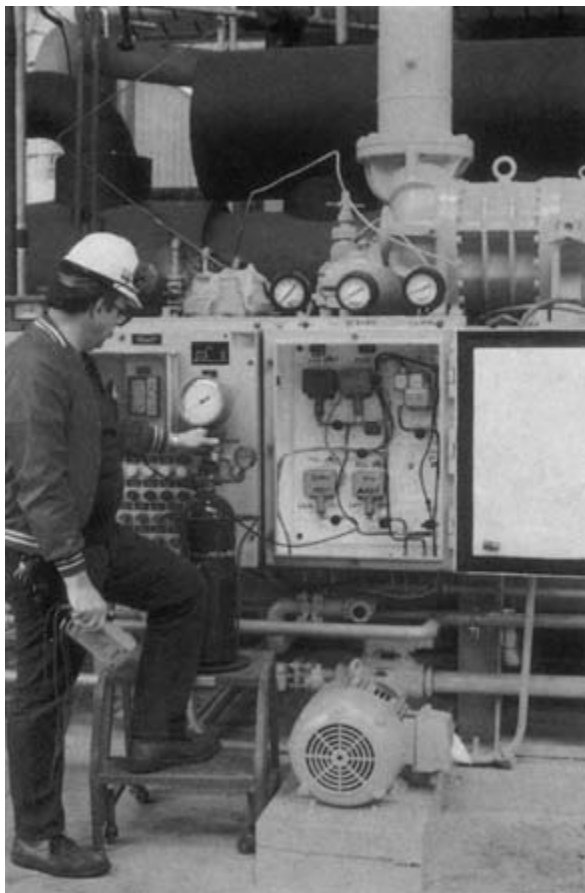
FIGURE 10–22 Prooftesting a high-pressure switch on a refrigeration unit.

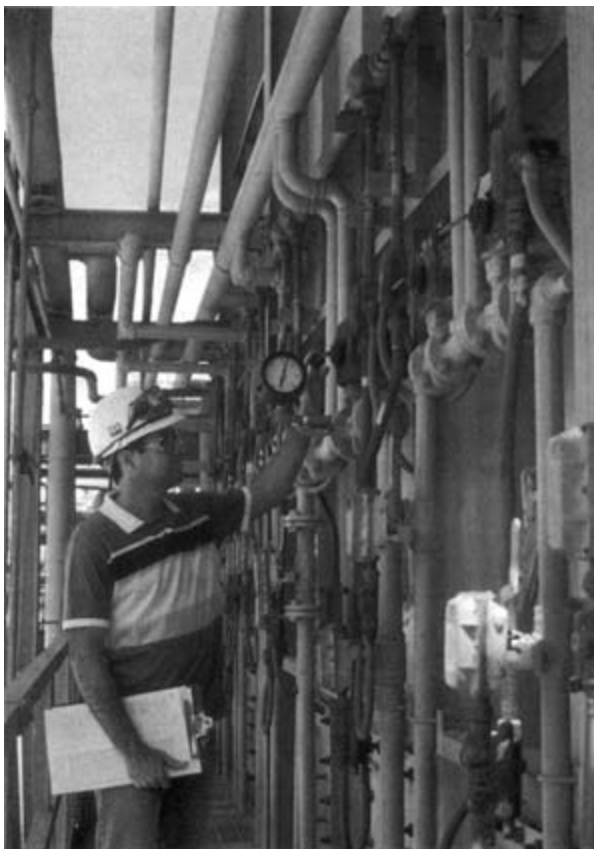
FIGURE 10–23 A chemical process operator relies on a furnace fuel shutdown system.

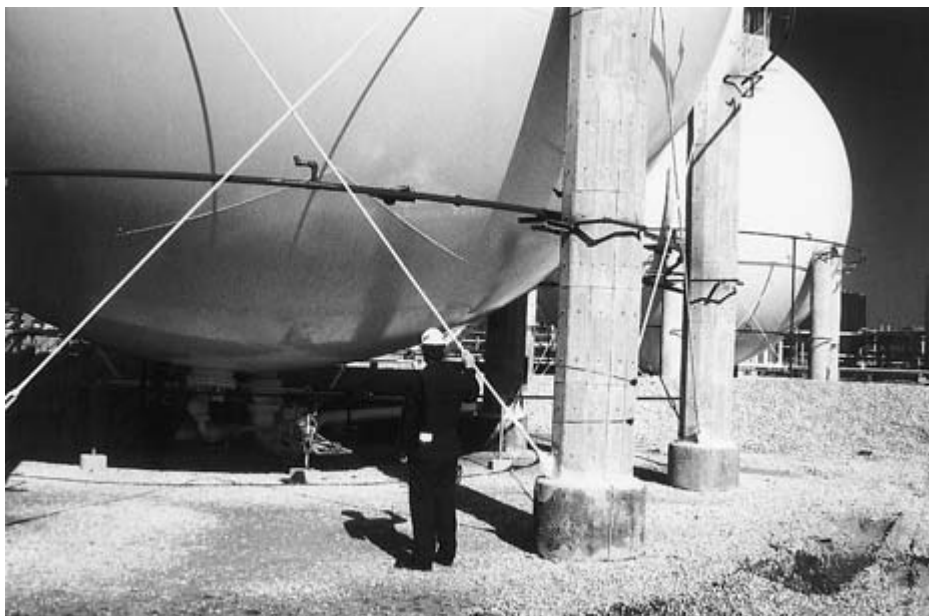
FIGURE 10-24 A chemical process operator witnesses the testing of an “Emergency Isolation Valve” below a sphere of flammable product.

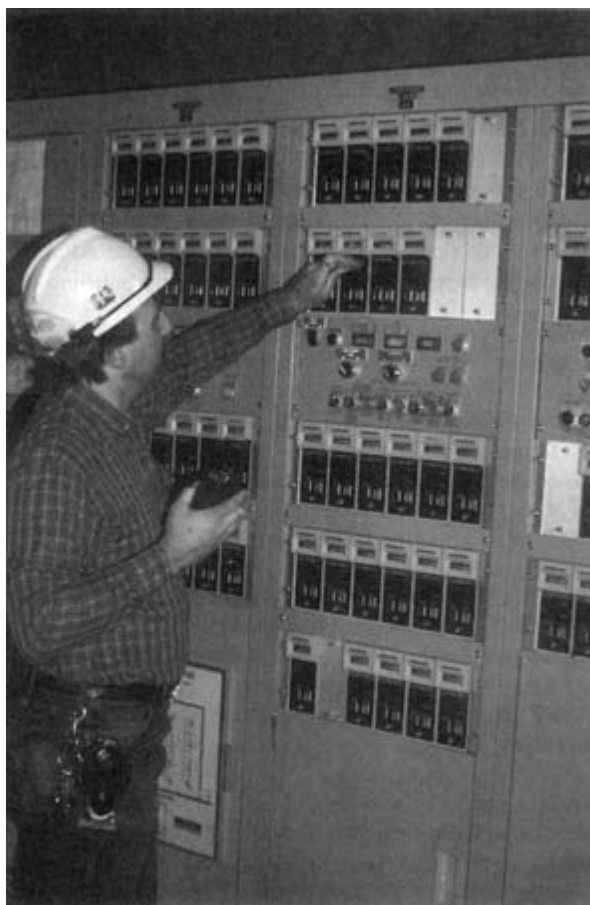
FIGURE 10-25 An instrument mechanic prooftests a critical instrument panel.

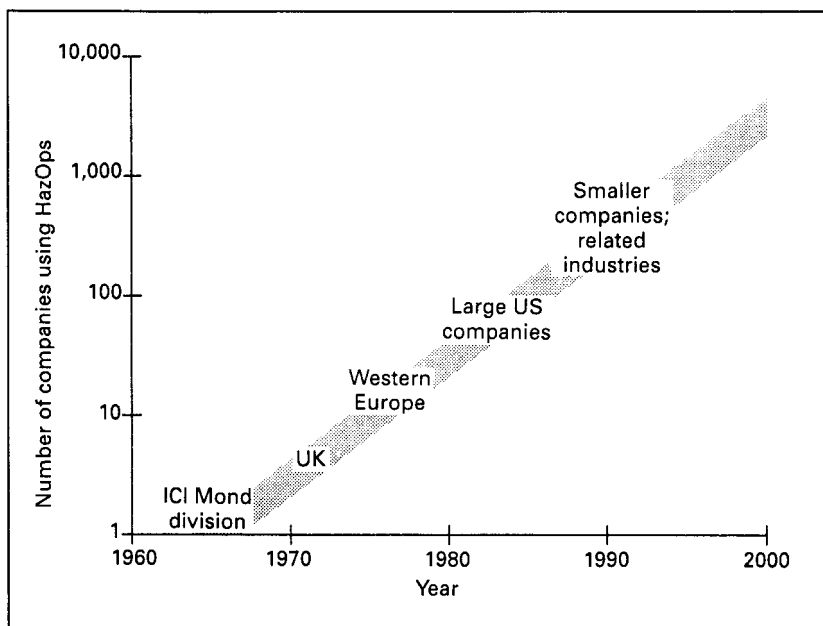
FIGURE 11-1 Estimate of the extent of HAZOP usage. Courtesy of R. W. Johnson, Battelle Memorial Institute.
